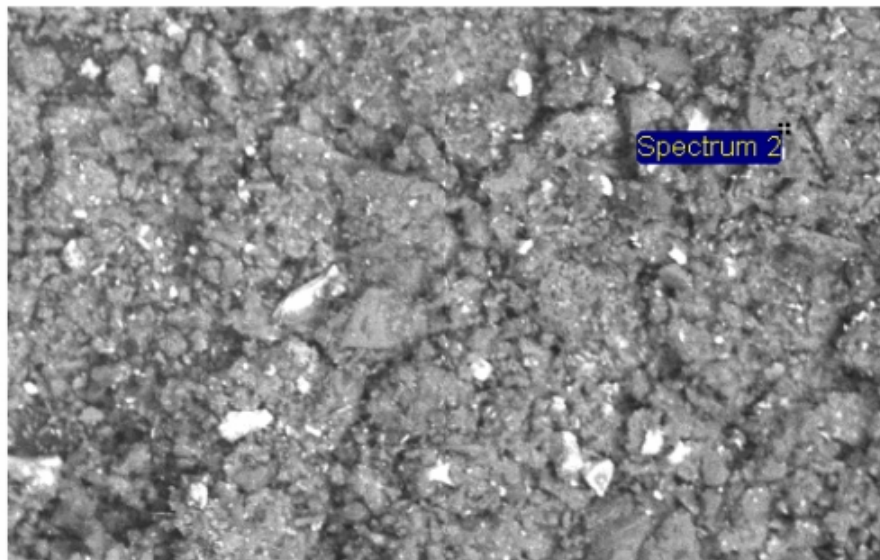
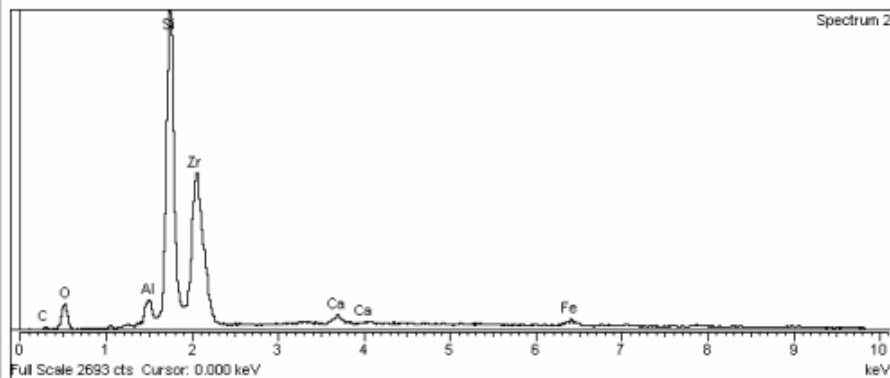
sample 1 - area 1

200µm

The chart to the left shows an SEM image of a deposit and a elemental analysis of a tiny area of the sample.

Through a sister company, Argüeso has access to a scanning electron microscope (SEM) fitted with an energy dispersive X-ray (EDS) analysis system. This allows the inferences to be made regarding the chemical nature and origin of ash samples.
